# AVN NAVSAFECEN MISHAP CODE SHEET

1. AIRCRAFT ACCIDENT BOARD APPOINTED BY OINC, VR-24 DET	2. SERIAL NO 1-69A	3. DTG (LOCAL) OF MISHAP 220103 MAR 69	4. MODEL AIRCRAFT C-7A	5. BUREAU NUMBER 746019
6. TO: Commander, Naval Aviation Safety Center	7. VIA: CO, VR-24	8. 11. TIME OF DAY Night	12. TIME IN FLIGHT 4.4	10. DAMAGE Substantial
9. LOCATION OF MISHAP NAF, Naples	13. FLIGHT CODE 3A4	14. CLEARED FROM CVA-38 TO: Naples	15. TYPE CLEARANCE I	16. AIRSPEED 160
17. A/C WEIGHT 18 050 24.4 <sup>2</sup> nac	18. ELEVATION AT TIME OF MISHAP S.L. 280 TERRAIN 0	19. BRIEF DESCRIPTION OF MISHAP Nose wheel up landing		
20. LIST MODEL, BUFG, REPORTING CUSTODIAN AND DAMAGE CLASSIFICATION OF ANY OTHER A/C INVOLVED (Complete OPNAV Form 3750-1 for each A/C) None

DAMAGE TO AIRCRAFT

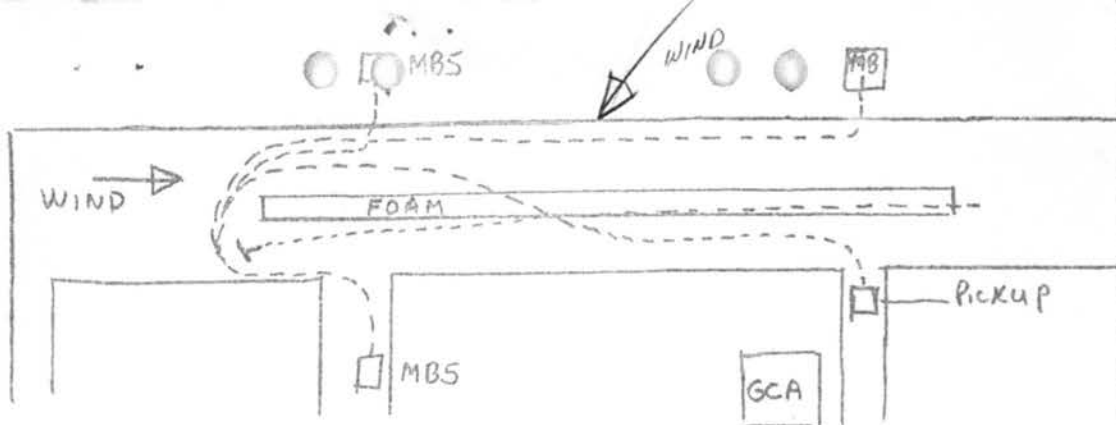
ENCLOSURE (1)  
Pg 2

The Crash Crew was notified at 2330 by telephone from the Flight Clearance Desk that a C-1A with a locked nose wheel that could not be extended would arrive at HAF Haplon in approximately 2 hours. The crash trucks arrived on the runway at 0040 and permission to foam the runway was granted at 0045. The foaming was completed at 0055. The distance foamed was approximately 1800' long and 30' wide. The aircraft landed at 0113 abeam of the GCA unit and stayed in the foam blanket for about 3/4 of the distance and then veered to the left side of the runway.

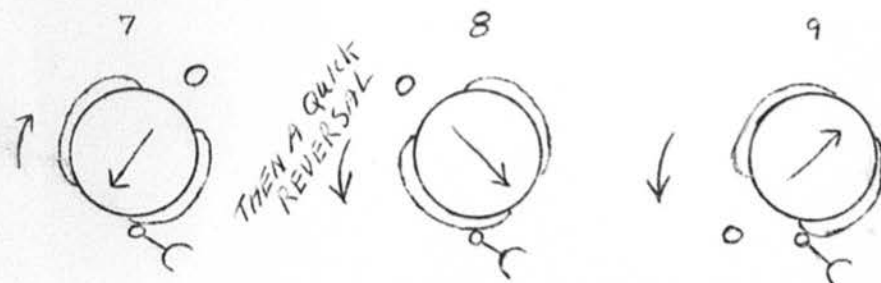
180° REVERSED

THE SEQUENCE WHICH RESULTS IN THE ROLLER AND YOKE BEING MISALIGNED

THEN A QUICK REVERSAL
